CLUTCHTECH

TSB-269

Pivot Ball and Clutch Fork Wear

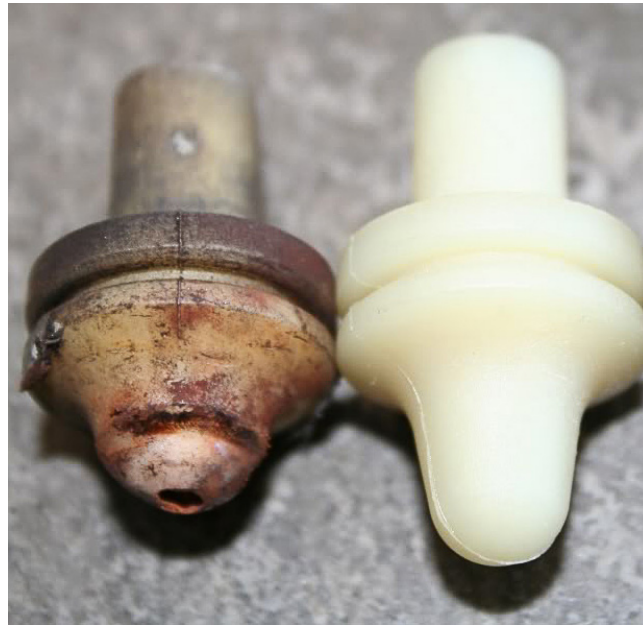
When removing the transmission of a car fitted with a clutch fork and pivot ball, it is important to check the condition of the 2 components. The contact points wear down and alter the working height and can cause operational issues when a new clutch is installed.

Below is an example of a used OEM plastic and New OEM Plastic pivot ball for the same application.

If there are any signs of wear/ damage it is highly recommended to replace the 2 components to prevent a failure or potential operational issues.

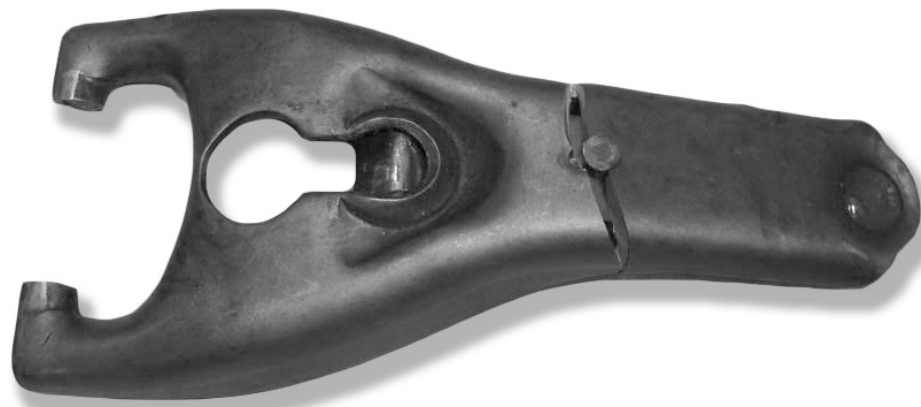
Ensure you check ALL contact surfaces while the fork is off the transmission.
