TSB-167

Concentric Slave Cylinders

To prevent a Concentric Slave Cylinder (CSC) from failing or being damaged it is important that you follow these simple guidelines whilst handling and/or fitting the slave to the vehicle.

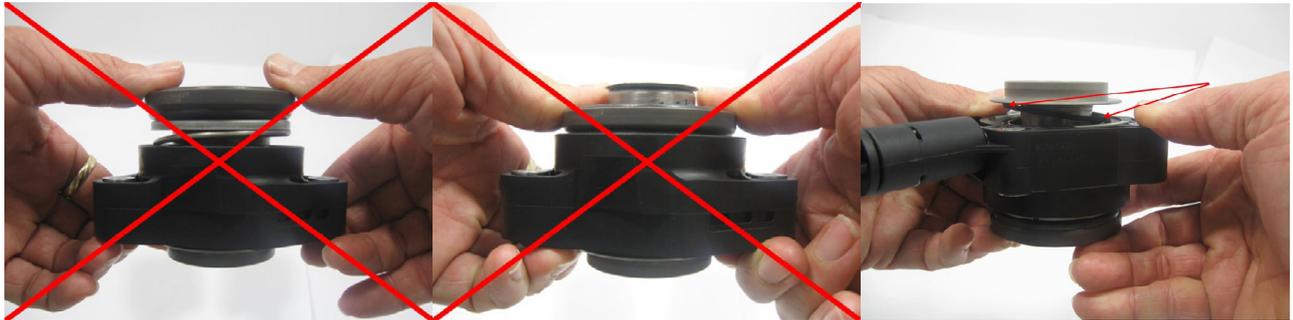
Every CSC is different so it is important to never depress the slave cylinder by hand prior to fitting to a vehicle. This can dislodge the seals in the back of the slave without being noticed. As a result the slave may leak once installed.

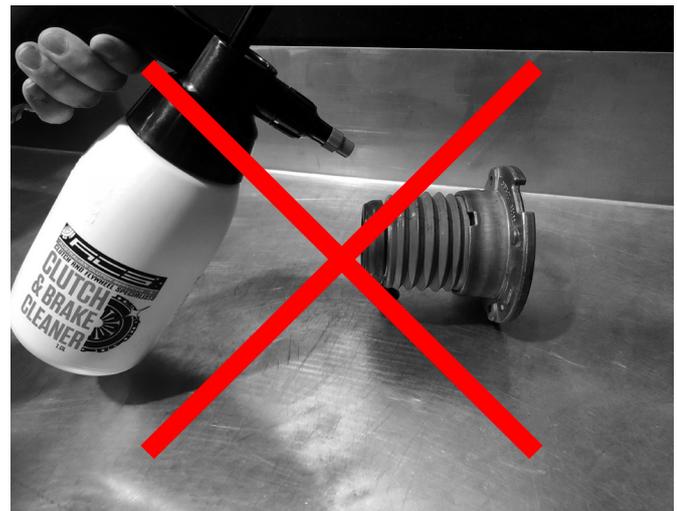
Never spray brake cleaner or solvents in or around the CSC. This can cause the seals to swell and wash away the assembly lubricant.

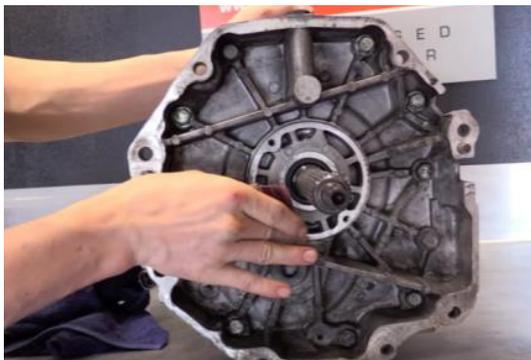
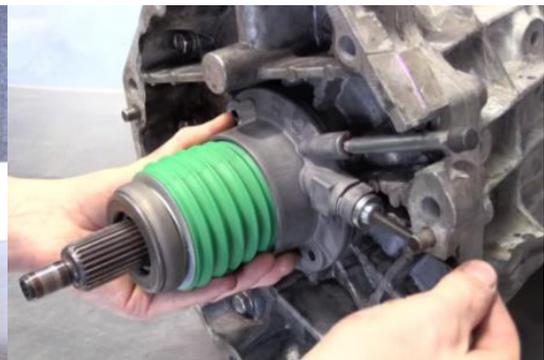
Check the supply pipes to the CSC, if damaged, blocked or fatigued the pipes will need to be replaced. Clean and check the mounting surface of the CSC on the transmission. Replace gaskets, seals or sealing compounds as per the manufacturers specifications. The mounting surface needs to be free of dirt and contaminants along with ensuring there are no burrs or corrosion on the machined surface. Carefully mount the CSC on the transmission and check that it fits square on the mounting surface. Also ensure that the pipes do not foul on the transmission.

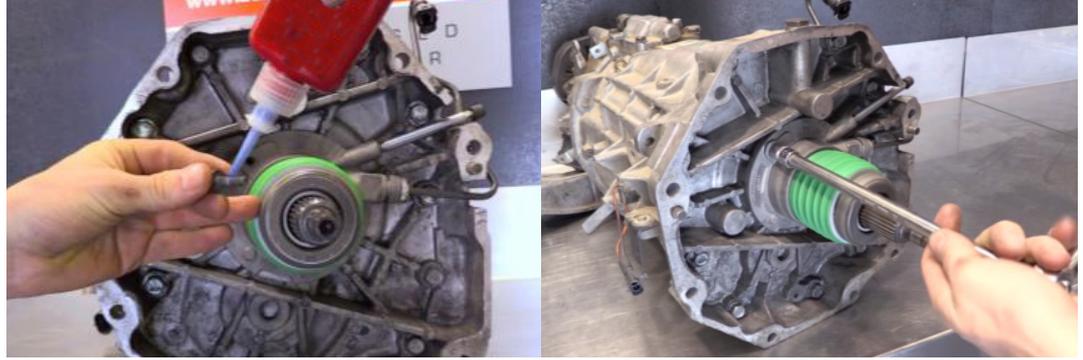
Use thread locking compound on the mounting bolts and torque to the manufacturers specifications.

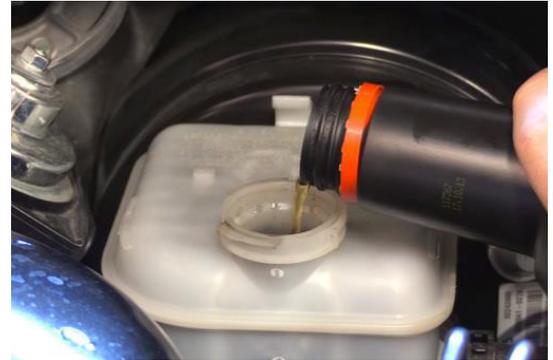
When fitting a new Concentric Slave Cylinder (CSC) it is important to take great care bleeding the hydraulic clutch system. Over pressurizing the concentric slave cylinder can cause the cylinder to fail. Please follow the manufacturer's recommended manual bleeding procedure. Where there is no procedure specified, follow the process below:

- 1) Fill the reservoir with the applicable clutch fluid to the manufacturer's specifications.
- 2) Open the bleeder nipple on the braided bleeder line and have someone in the vehicle slowly depress the pedal to the floor by hand. Close the nipple and return the pedal to the top. Repeat the process of passing the fluid through 4-5 times.
- 3) Change the process to slowly depressing the pedal to $\frac{3}{4}$ stroke and holding by hand before opening the bleed nipple. Lock the bleed nipple and return the pedal to the top. Repeat this 4-5 times whilst maintaining the fluid level in the reservoir.
- 4) Check that the clutch has full release and the pedal is not spongy. If the pedal is still not satisfactory repeat step 3 using a full pedal travel.

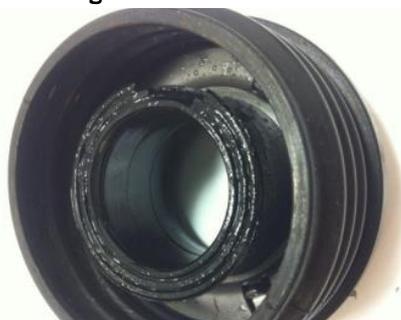
If a piston is over stroking this can cause damage to the end of the guide tube or even to the piston seals. Over stroking can be caused by several things such as incorrect pedal adjustment or incorrect clutch fitment causing low installed height.

Damaged Seal

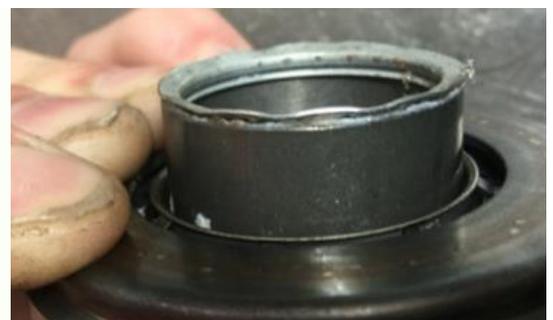
Damaged Piston Stop

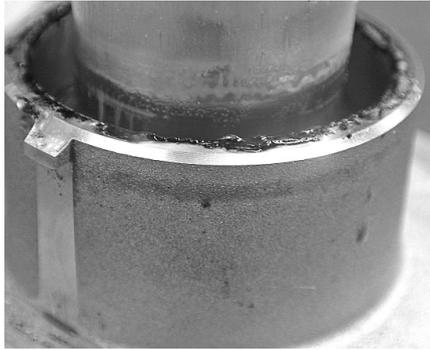
Whenever a hose/pipe is disconnected from the slave cylinder, ensure that the seal/O-ring has come out as well and inspect it carefully. If the seal is swollen or damaged it will need to be replaced. Damaged seals can cause leaks or deteriorate and induce blockages in the slave cylinder or lines resulting in a hard pedal.

Deteriorated Seals

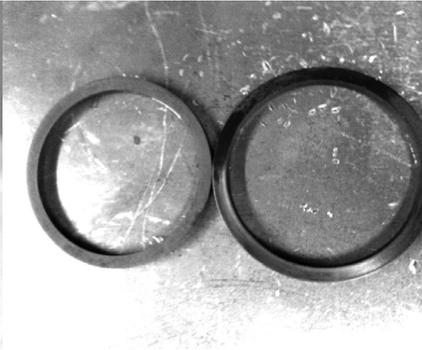
Swollen Seal

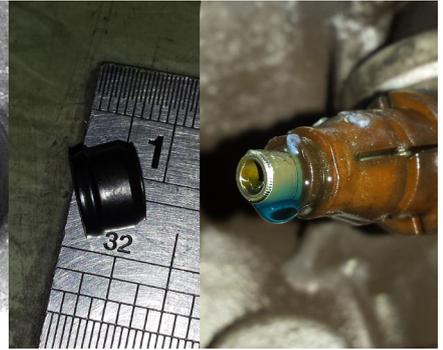
Missing Seal

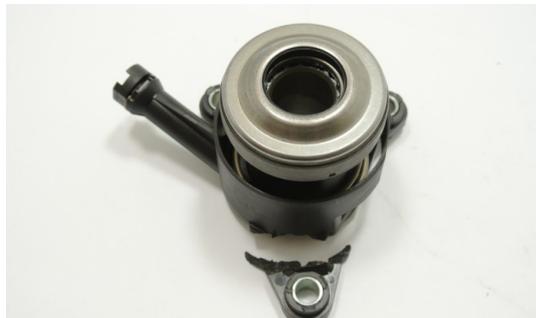
Mounting a CSC off axis, incorrect bolt torque or bolt quantity can cause several problems. This can cause the CSC to leak or have a staging pedal. The indicators are broken tabs or inconsistent wear on the guide tube

Broken Tab

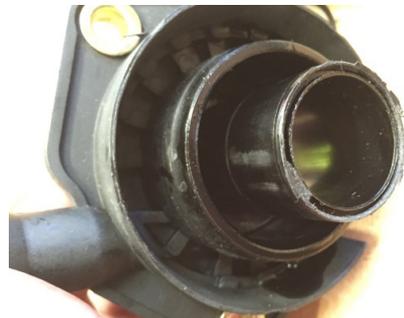
Off Axis Wear On Guide Tube

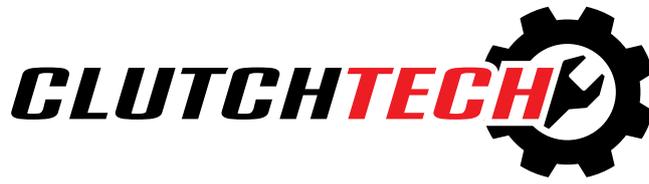
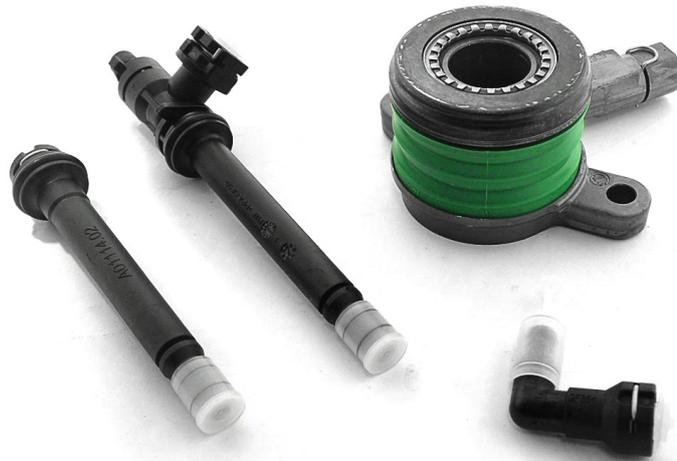
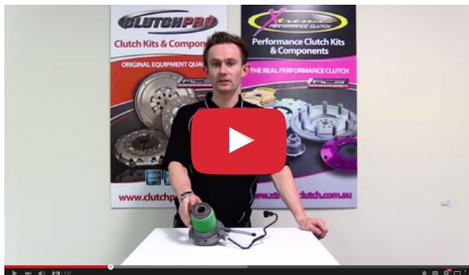
Multiple Components

Some Concentric Slave Cylinders come with a range of pipe/ line fittings due to them fitting multiple applications. In this instance, take note of the original pipework from the vehicle and match them to the supplied components before disposing of the old cylinder/ fittings. You may not need to use all of the new fittings supplied.
